# **Heritage Impact Assessment of the Nessie Knight Hospital near Qumbu, and the Mjanana District Hospital near Encobo, both Eastern Cape**

# Heritage Impact Assessment of the Nessie Knight Hospital near Qumbu, and the Mjanana District Hospital near Encobo, both Eastern Cape

## Contents of Report:

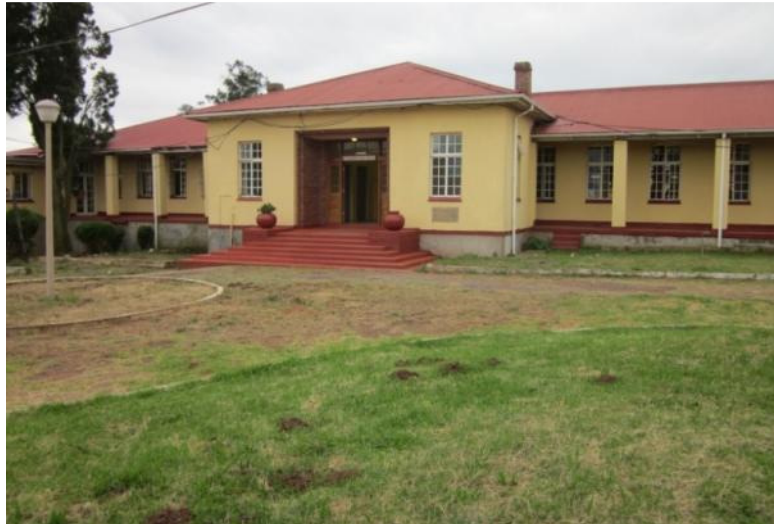
This is a symmetrical building which has been subject to incremental development and some rather unfortunate accretions. The front part is coherent and will not be affected, but the rear sections, noted as building No 4 in Figure 3, is intended for demolition. The latter is asymmetrical, unlike the main façade, and is irrational in its layout, making it a rabbit warren and difficult to reuse, or improve. Of note is the wide passageway running through from front to back joining the two. Furthermore, building 2 (an electrical substation) and building 3 have been positioned so that the spaces between these and the main wards and its extension buildings are not conducive for use nor aesthetically pleasing.

**Figure 7: Main ward building opened by the Right Honourable Lord Maclay, President of the Nessie Knight Club, in May 1938. The foundation stone is to the right of the entrance.**

**Recommendation: MAIN WARD BUILDING**

**Demolition is not an option at this point. The building is solid and well built, but at the same time needs urgent and well supervised maintenance. The services of an appropriate heritage architect should be engaged in informing the links between the old building and the proposed new extension in line with prevailing conservation charters. A defined but negative junction must separate the two buildings, and it is recommended that the new building take some clues such as massing and proportion of fenestration, openings and structure from its existing precedent.**

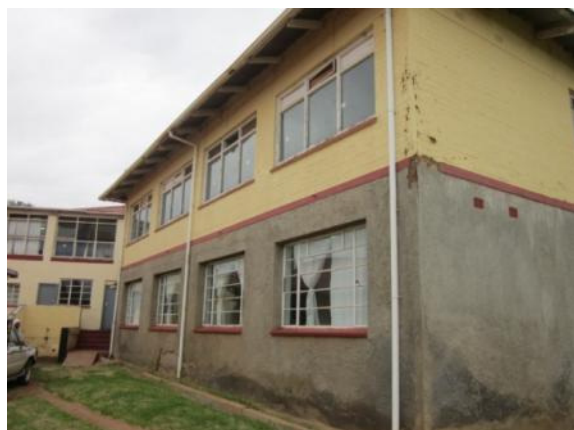
**Fig 9: Double store extension (north)**

Symmetrically arranged to both sides, are extensions which angle forward slightly, enclosing space. To extension to the north is double story due to the fall in level across the site, and that to the south is single story. Large chunks of rough cast plaster have fallen off these walls and the bricks are exfoliating from lack of maintenance, possibly an incorrect paint choice and rising damp. These

The walls are painted locally-made bricks, with a projecting string course which carries through the elevation tying the building up from the verandas at the front around to the back. Below the string course is rough-cast plaster painted grey. On the northern extension this plaster is spalling badly due to water retention problems through lack of maintenance. The roof is red painted corrugated sheeting.

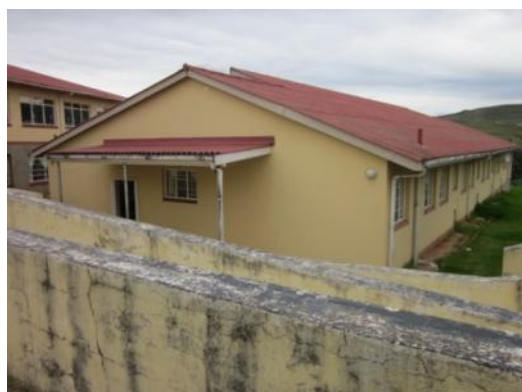
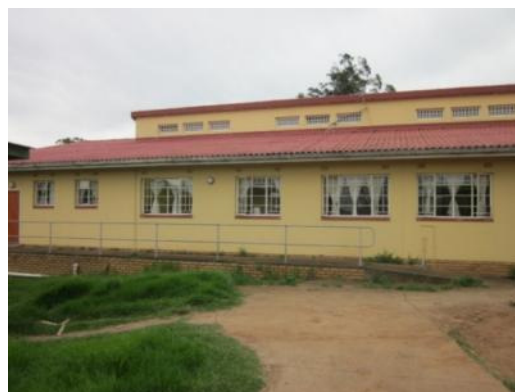
This building, like that above, is of recent construction: probably built simultaneously. It is of standard masonry construction with an asymmetrical corrugated 'Big Six' roof with clerestory windows indicating the route of the spinal corridor. It has standard section steel windows with asbestos cills. It is utilitarian and unremarkable.

**Fig 11 and 12: Hospital building from south west and north west**

**Recommendation: NEW HOSPITAL BUILDINGS (3)**

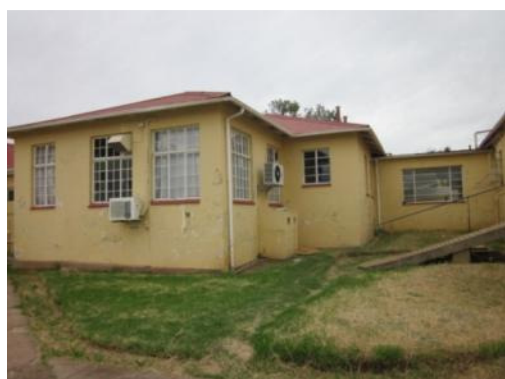
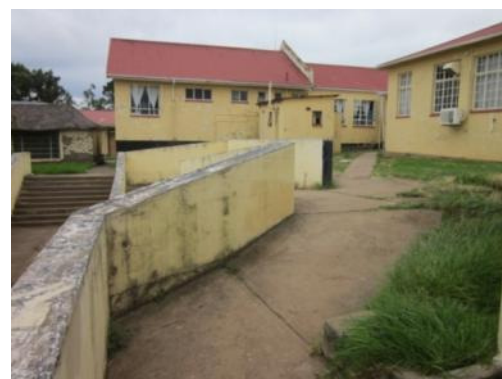
Building 4 is those accretions that are situated as extensions to the original hospital building at the rear of the main wards. Diagnostic features such as window cills and ventilation bricks show that this building was constructed in a number of different phases, which has led to a rabbit warren of spaces which are difficult to use inside, and outside a series of small, useless, courtyard spaces results. Furthermore, cascading roof heights on the north-eastern extension, add to the lack of syncretism.

**Figs 13 & 14: Rabbit warren of spaces forming the rear extension to the main hospital**

A redeeming feature of this building is the set of mahogany doors which are located on the veranda on the long north eastern elevation. It is recommended that these doors can be redeployed, perhaps at the junction of the old building and the proposed new extension to the rear.

**Recommendation: REAR EXTENSIONS TO MAIN WARDS (4)**

**Demolition is an option and it is recommended that the entrance doors on the north eastern elevation be reused in the design of the proposed extension to the main wards.**

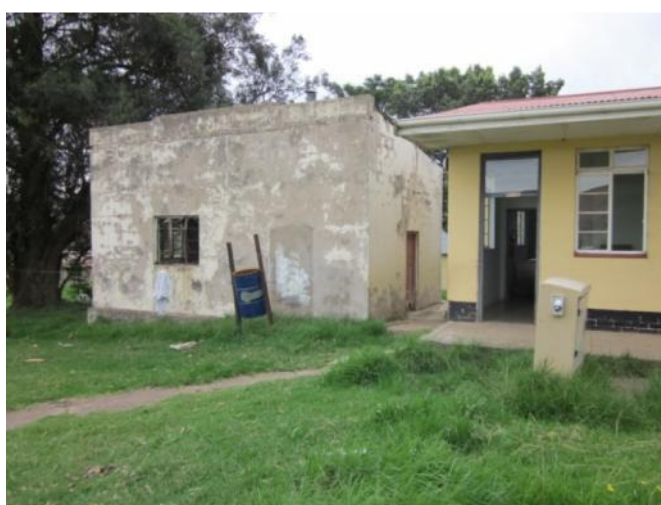
This building is an unremarkable masonry-constructed building with a parapet wall to the north-west. It has meranti timber doors and steel windows. All diagnostic features point to relatively recent construction.

***Fig 23: Mono-pitch structure***

***Recommendation: MONO-PITCH STRUCTURE (7)***

***Demolition, should it be sought, is an option.***

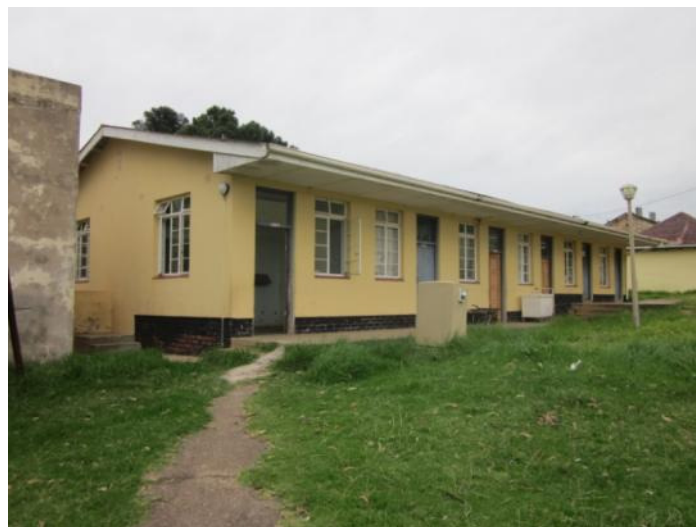
***Fig 24: New hospital building***

Possibly built at the same time as buildings 2 and 3 above, this building is of recent construction. It has a simple double-pitched corrugated sheeting roof, and is constructed to standard details using standard materials. It has meranti doors and steel windows and is unremarkable; it has no heritage value.

***Recommendation: NEW HOSPITAL BUILDING (8)***

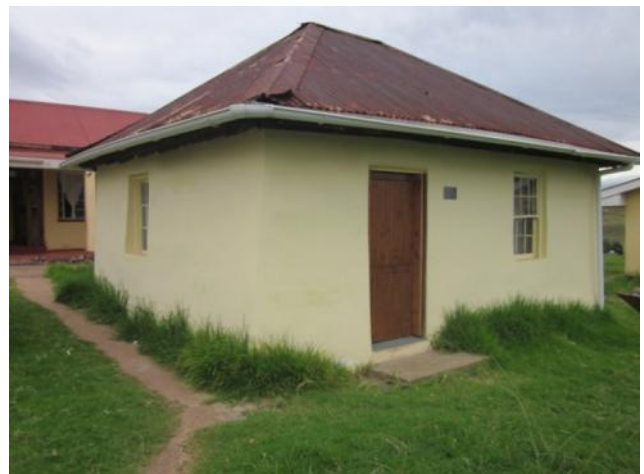
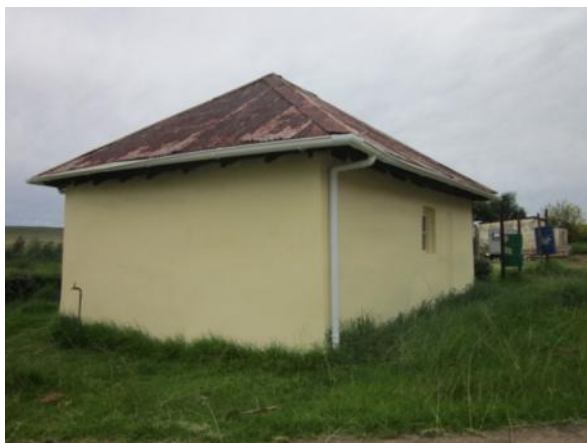
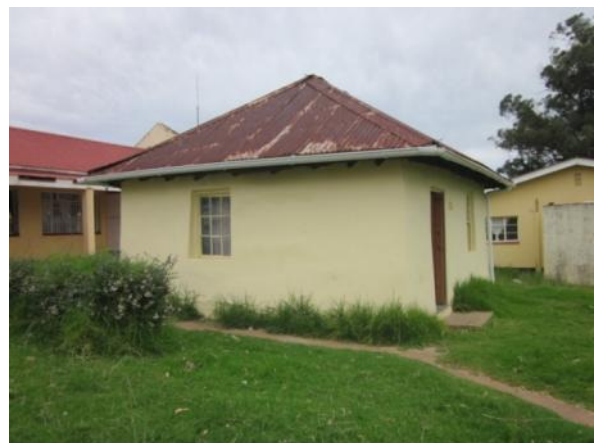
**Fig 28: Front elevation of dispensary**

**Fig 29: Dispensary from north**

**Fig 30: Dispensary from south**

It is noted that, in an environment in which little maintenance has been carried out on the main building for many years, this little building has not only been maintained, but has a plaque recording its origin. Some inappropriate changes have been made, such as the insertion of a new door, and the erection of plastic gutters to the roof. The building is also plastered and painted. Little evidence of the efforts of Robert Lamb Paterson appear to exist on the site, and this building's good condition and careful preservation shows a single acknowledgement of this.

**Statement of significance:** *Highly significant locally and regionally. It is strongly recommended that the current design proposals endeavour by all means to retain this building, (enclosed within a courtyard?) and that it serves as a museum of the Nessie Knight Hospital in the new development.*

**Recommendation:** *OLD DISPENSARY (9)*

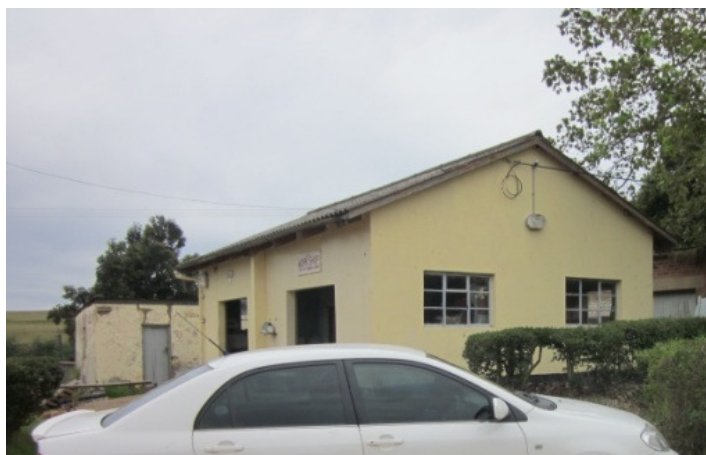
The workshop is a brick and mortar structure under a corrugated sheeting roof, of more recent construction. It has steel windows and roller shutter doors. It is utilitarian and unremarkable in its construction.

***Fig 34: Workshop from west***

***Recommendation: WORKSHOP (11)***

***Demolition, should it be sought, is an option.***

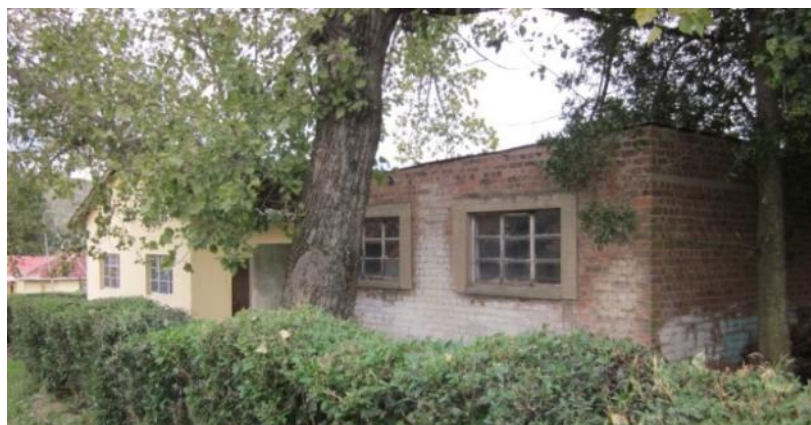
This building is also an industrial type building of relatively recent construction, but still using locally made bricks. It has steel windows and these have plastered bands surrounding them. It has a mono-pitch corrugated iron roof. It is architecturally unremarkable.

***Fig 35: Building behind workshop***

***Recommendation: BUILDING BEHIND WORKSHOP (12)***

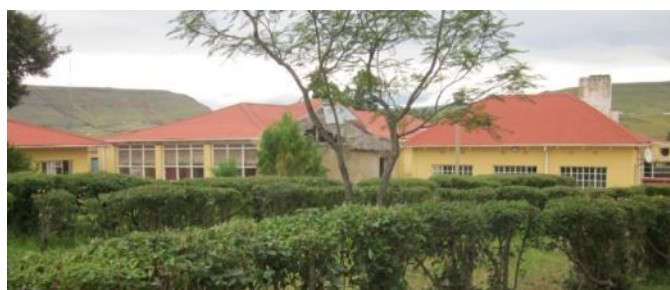
See comments for similar building in 3.5 above. Despite it being in better repair than its counterpart, the practicality of its repair and reuse is limited, and it is felt that it is important to concentrate the repair and reuse of such buildings to other parts of this site.

***Fig 37: Old mud brick rondawel against main wards***

**Recommendation: OLD RONDAWEL (13)**

**Due to its condition and location within the extended development, demolition is an option**

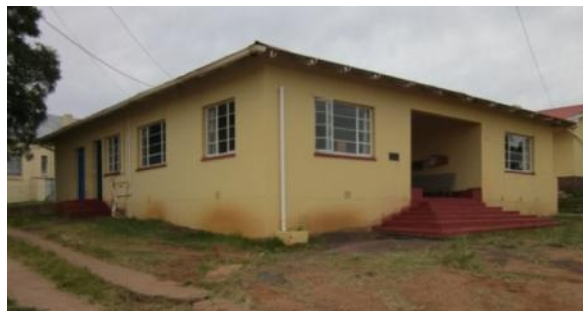
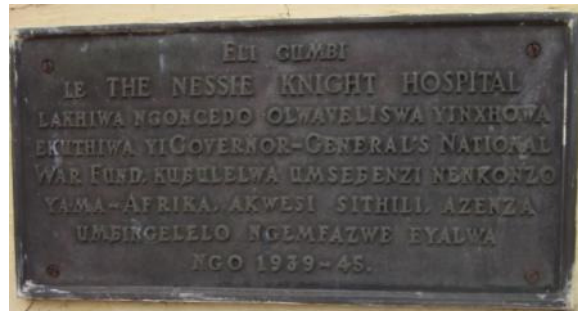
This building is diagnostically confusing. It is a simple structure erected some time after World War II since it was erected through funds supplied by the Governor General's National War Fund. This building is intended for development in a second phase.

Architecturally, it is unremarkable, with a hipped corrugated iron roof, and steel windows. The front entrance is the only section which demonstrates any ceremony: it has a central, deep entrance veranda which is accessed by stairs reminiscent of the main ward building, with raised benches which possibly were built to accommodate jardinières as in the main building. The dark entrance has a central door flanked by two vertically proportioned windows. Notable is the plaque mounted on the wall at the entrance, describing the origins of the funding in Xhosa.

**Fig 38: Hospital Building ca 1946 from west entrance**

**Fig 39: Plaque at west entrance**

**Recommendation: HOSPITAL BUILDING ca 1946 (14)**

**Demolition, should it be sought, is an option. However, should demolition be sought, the building should be fully documented and the plaque removed. This information should form part of a display on the Nessie Knight Hospital in a museum on the site**

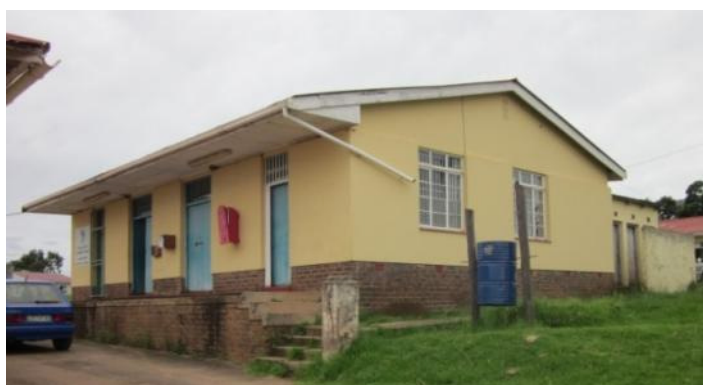
This hospital building is of plastered and painted brick and mortar construction on face brick plinth under a corrugated iron double- pitched roof with bird-proofing to the eaves. It is of recent construction. It has steel windows and painted hardwood doors. It is utilitarian and unremarkable in its construction.

**Fig 40: Hospital Building (building 15)**

**Recommendation: HOSPITAL BUILDING (15)**

**Demolition, should it be sought, is an option.**

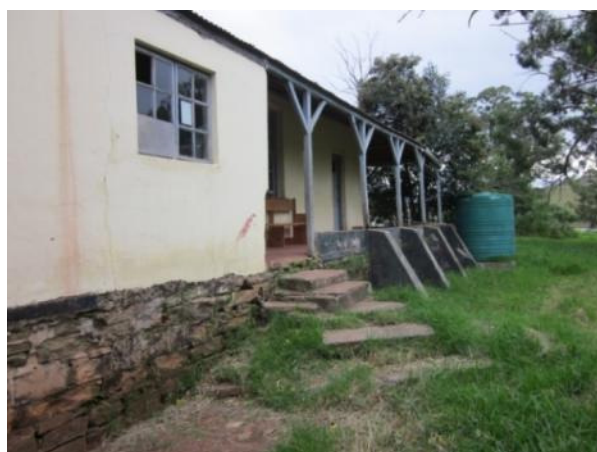
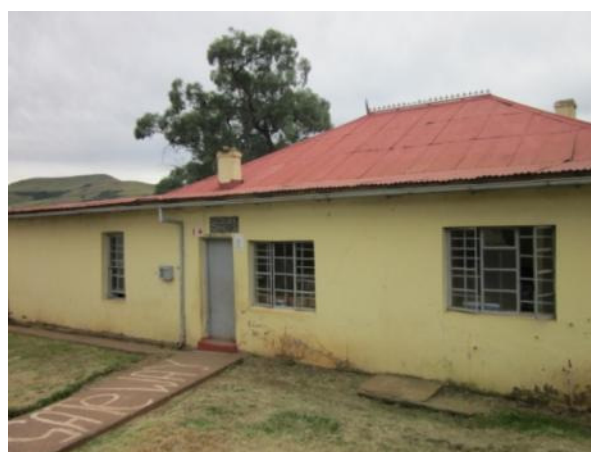
**Fig 41: Old Mission Building, east north east**

**Fig 42: South west elevation**

This old Mission building, most likely a mission house, is currently housing an HIV/AIDS centre. It has been much altered over the years, but still bears the diagnostic features of its late Victorian construction, such as the iron work on the ridge of the roof, some basket arches over windows and cast iron sub-floor ventilator bricks. The verandas appear to have been added afterwards. Photographs in the 'Sulenkama' pamphlet of the first buildings were scrutinised in order to be able to match this house, but the evidence was not conclusive. This building could have operated as a school, or a house.

The building is of uncertain construction, most likely a mixture of mud and fired brick, under corrugated sheeting. Windows vary from original sash to standard steel sections, added at a later stage. It is founded on a mixture of shale and sandstone, much of which is exfoliating. Verandas have a simple 'Y' post, and the veranda to the north east is heavily buttressed to prevent it overturning.

**Recommendation: OLD MISSION BUILDING (16)**

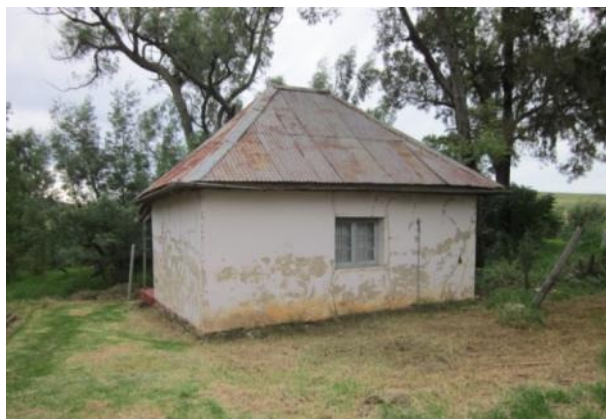
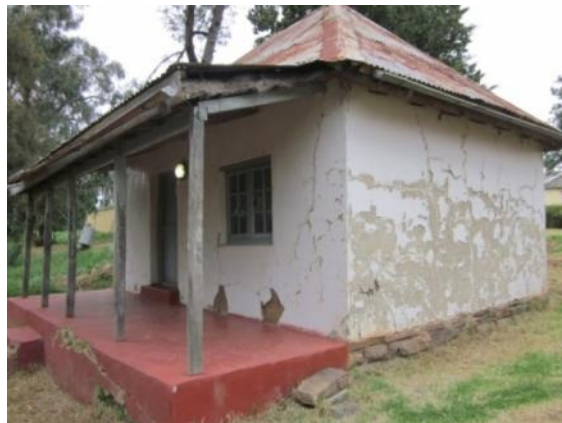
### **C.17 Building 17 – Old Mission cottage**

An old mission cottage is situated adjacent to the building described in C16 above. It is most likely of mud brick, given the examples surrounding it, and, like the others, has a thatched roof that has been covered latterly with corrugated iron. The windows are timber casement and the veranda posts are simple timber.

**Fig 45: Old mission Cottage**

**Fig 46: Cottage, front elevation**

**Recommendation: OLD MISSION COTTAGE (17)**

*This building is not officially threatened but it could be in danger in the new development. Should demolition be sought, a full and separate Heritage Impact Assessment should be carried out. All renovation works should be supervised by an appropriately qualified heritage architect. Further research needs to be carried out on the role of the Church of Scotland in the establishment of Sulenkama Mission*

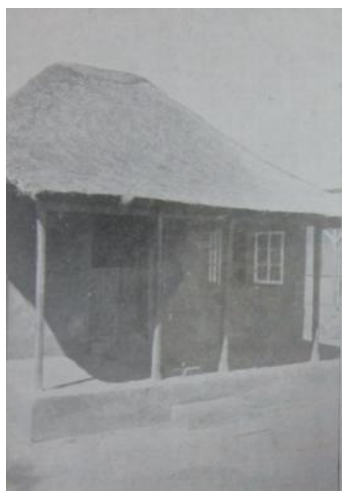
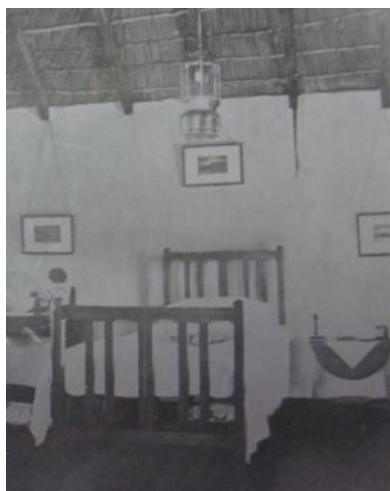
**Fig 47: Front of cottage ca 1927 Fig 48: Interior ca 1927**

Certainly, this building was extant in the time of Robert Lamb Paterson as this was his home for two years when he first arrived at Sulenkama (see Fig 47 and 48, both from the pamphlet 'Sulenkama').

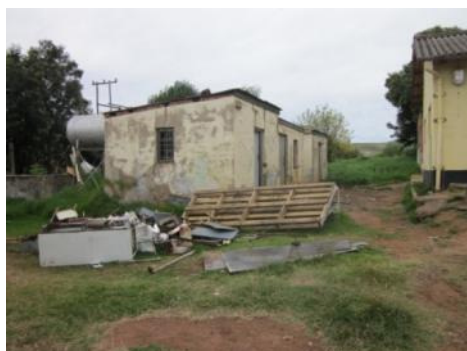
### 3.18 Building 18 - Accommodation block adjacent to workshop

This building consists of a row of utilitarian accommodation of mixed construction, plastered and painted under a mono-pitch corrugated sheeting roof. It has timber casement windows, but its origins are much more recent than the examples in C16 and C17 above. It has had attempts at maintenance over the years, and is currently in need of further attention. It is architecturally unremarkable and does not contribute in any major way to the cultural landscape of the site.

It is in line for demolition in the new development.

**Recommendation: ACCOMMODATION BLOCK ADJACENT TO WORKSHOP (18)**

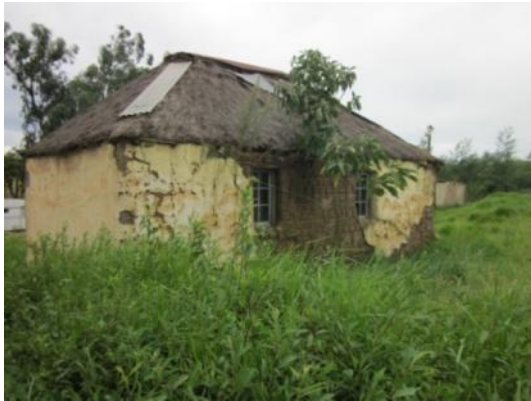
A series of square mud brick cottages is found across the site. Below the main hospital on the eastern slope is a continuous group of four with one located further up the slope, and two which form part of the main complex on the crest of the hill. One of these has been addressed in C6 and the other is situated close to the old mission house, and backing onto hospital buildings of more recent construction. Most, except for the latter, are either totally derelict, or in a sorry state of repair.

**Fig 52: Typical state of cottages**

#### **Recommendation: OLD NURSE'S QUARTERS**

*Some of these buildings, especially those on the crest of the hill, fall within the footprint of the new development. Those on the eastern slope are theoretically largely 'untouched' but it is unlikely that they will survive the development. As threatened buildings they should be fully documented, and measured up, and the information form part of a display in the museum. It is highly recommended that one of these buildings should be identified for rehabilitation as an example in the new development. The building situated behind the mission house is possibly the best option. Should renovation or demolition be sought, a full and separate Heritage Impact Assessment should be carried out. All renovation works should be supervised by an appropriately qualified heritage architect. Further research needs to be carried out on the role of the Church of Scotland in the establishment of Sulenkama Mission*

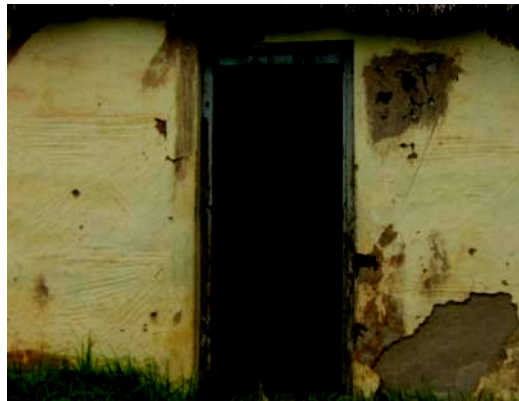
**Fig 53: Finger decorations to wall**

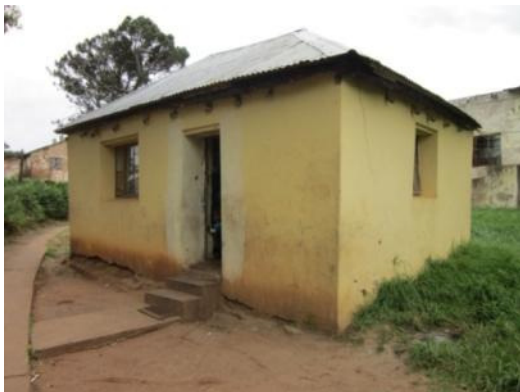
**Fig 54: Building below main wards**

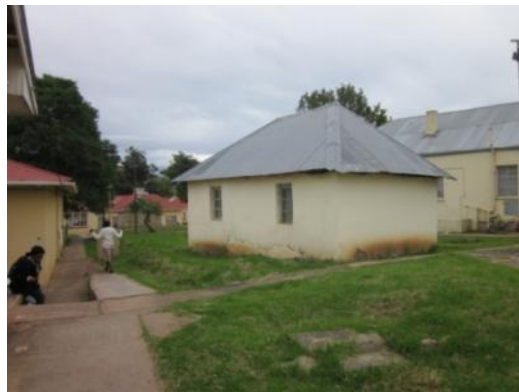
**Fig 55: Example most likely candidate for rehabilitation**

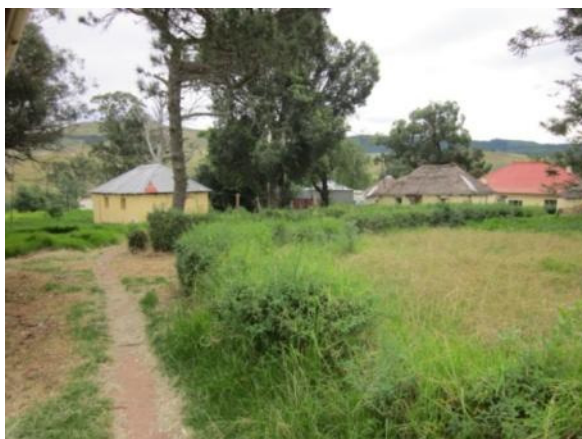
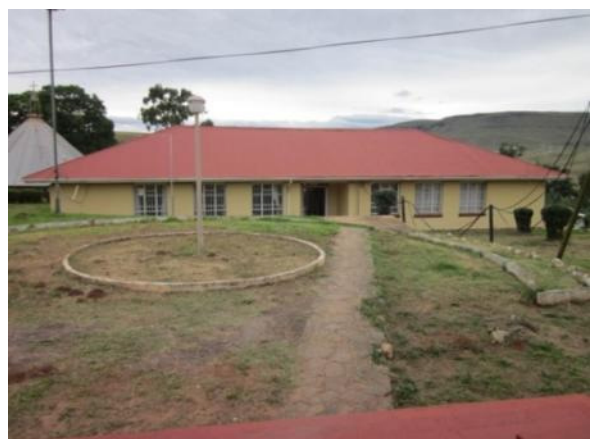
**Fig 61: View to east showing May-lined parterres Fig 62: Hard landscaping outside main wards**

The physical landscape is also of import. The ‘Sulenkama’ pamphlet shows examples of the early gardening endeavours, and this ethic was patently perpetuated through the years. Importantly, this has remained up till today: although much of the more delicate landscaping within the broad structure is no longer addressed (see Fig 62), the May hedges which are old plants, continue to be boxed,

emphasising the outlines of former rose gardens and parterres. This vestigial ethos should be recognised, and landscaping carried out on the site which recognises the historical patterns, yet reinterprets it in a contemporary, perhaps more sustainable manner.

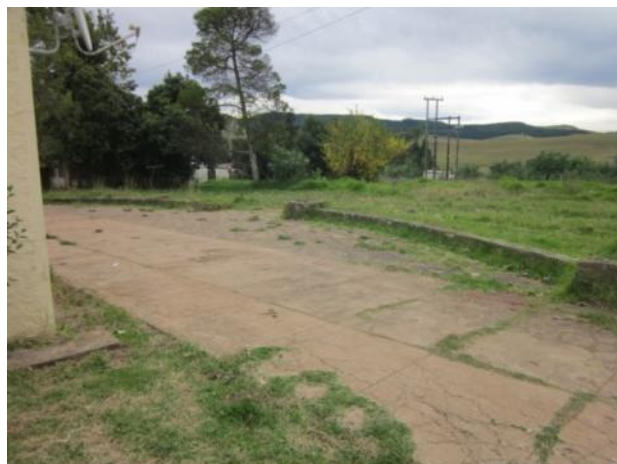
**Fig 63: Hard landscaping outside Mission House**

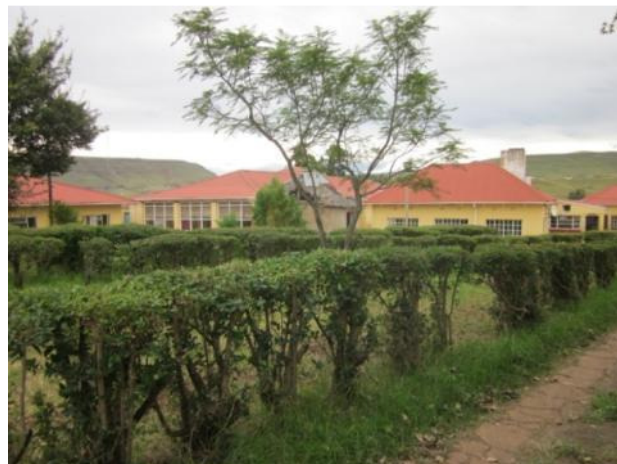
**Fig 64: Parterres**

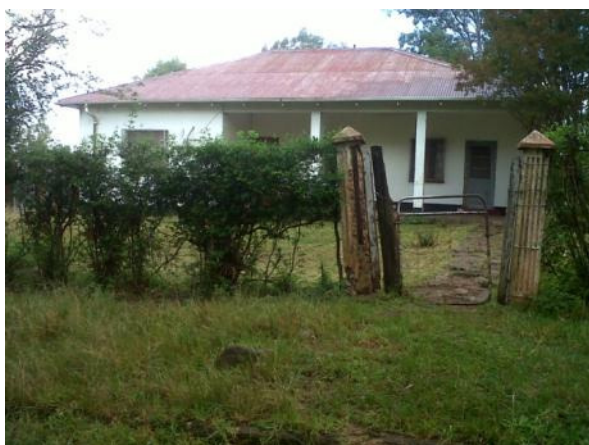
### **D.2 House no 1**

***Fig 69: House no 1 from north***

This house is of conventional construction of brick and mortar and plastered and painted under a hipped corrugated iron roof. It is situated on a painted stone plinth. The windows are standard steel section, and the doors are timber. A veranda runs along part of the front elevation, supported by square masonry columns. It is enclosed on the end with a wall, in which is a single porthole window.

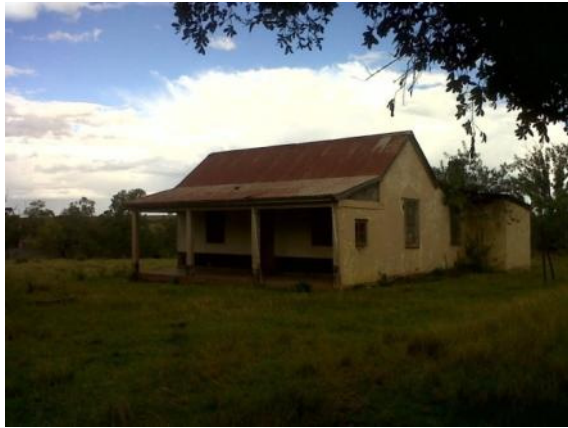
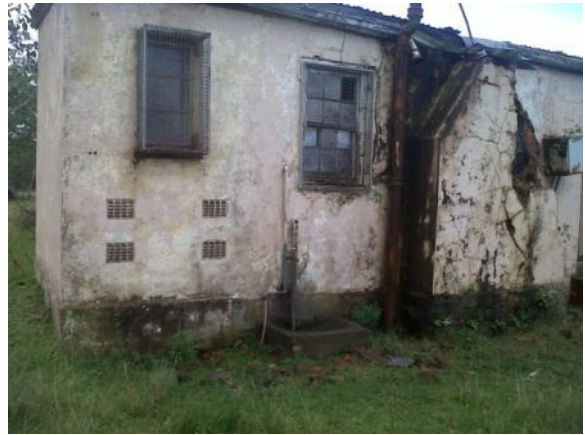
### House no 2

***Fig 70: House no 2 from north***

***Fig 71: Southern elevation with wild fig***

House number 2 is late Victorian, possibly 1895. It is a saddle-roofed corrugated iron building with a front veranda which has an end wall perforated with a single window. It is suspected that the veranda posts and beams have replaced any timber construction, and that the latter has been underpinned in the distant past, evidenced by the structural failure of the veranda. It is built of locally-made brick, which is soft, meaning that its strength over time is compromised with lack of maintenance which has led to large parts collapsing. Windows are timber, largely 6/6 sash, and hail guards have been mounted to most windows.

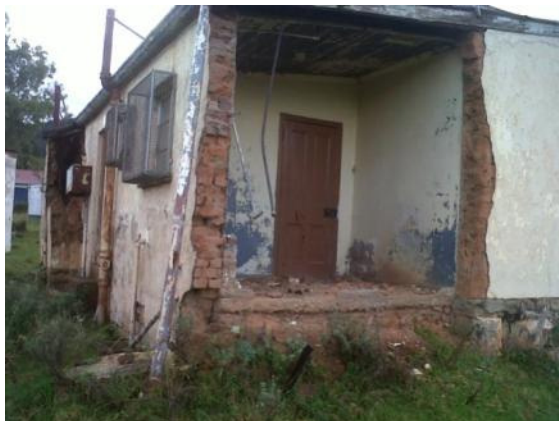
***Fig 72: Wall of east room***

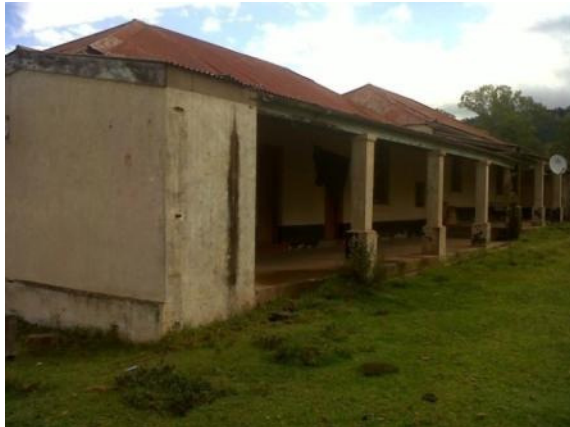
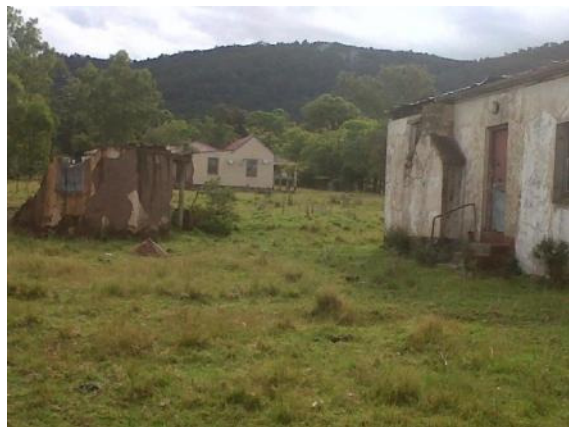
It is of locally made brick, and a mixture of mud brick, plastered and painted under a hipped corrugated sheeting roof. It comprises two separate structures which have been joined together with a common veranda which acknowledges the change in level between them. The veranda posts are cumbersome brick piers, possibly added later after the original timber ones had rotted. A mud brick addition has been added to the rear. Channels run from the rainwater goods out into the garden.

***Fig 74: View of house from north east***

***Fig 75: Showing proximity to House 2***

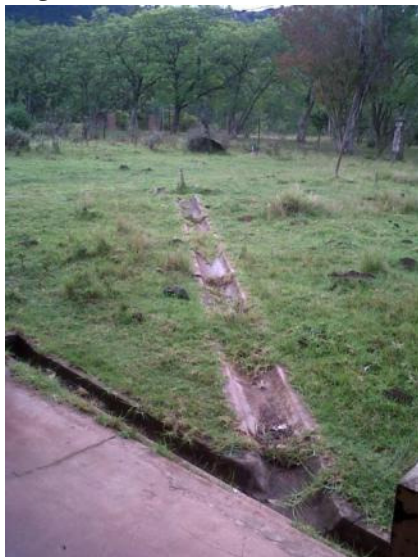
***Fig 76: Channels into garden***

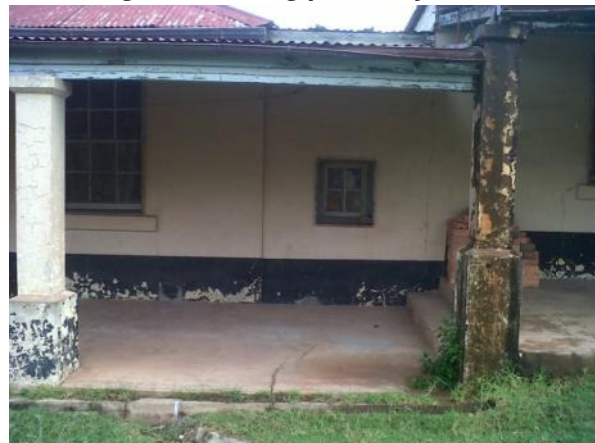
***Fig 77: Veranda junction***

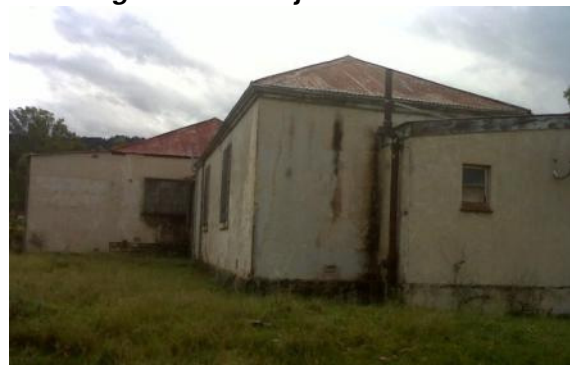
***Fig 78: Accretions to rear***

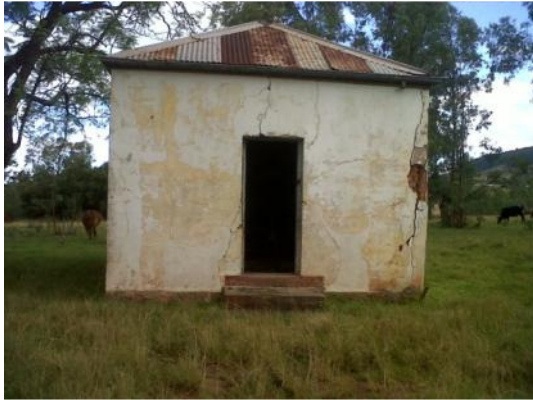
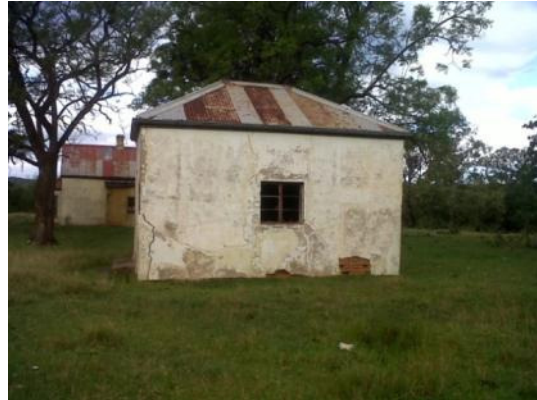
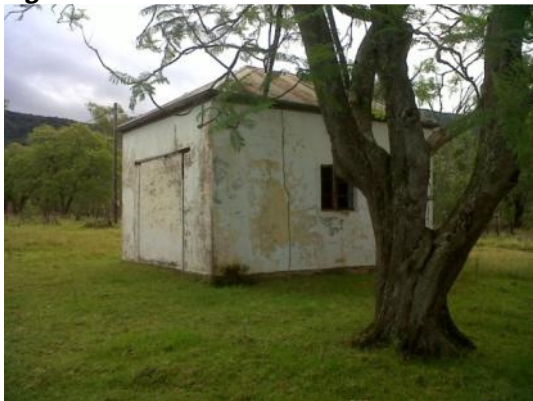
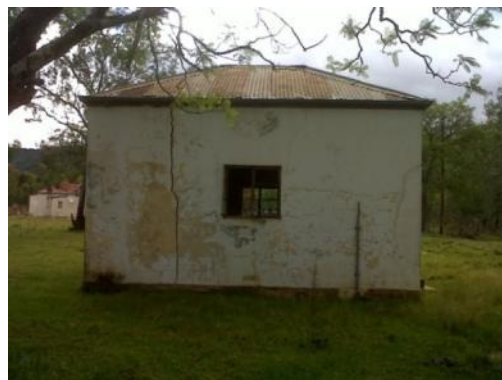
## **D.5 House no 4**

This building served as a wagon shed or garage. Constructed in English bond with locally made bricks, it is now structurally unsound. It has a hipped corrugated- iron roof and steel windows to two elevations and a timber door to one.

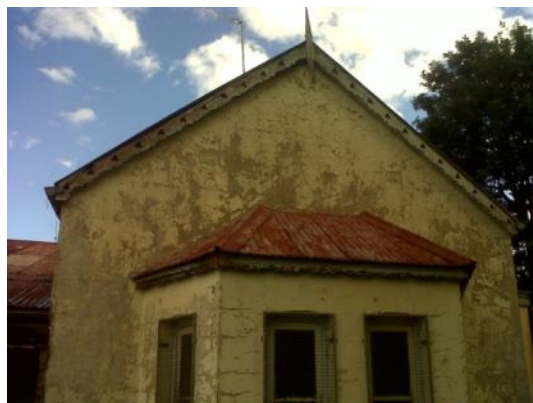
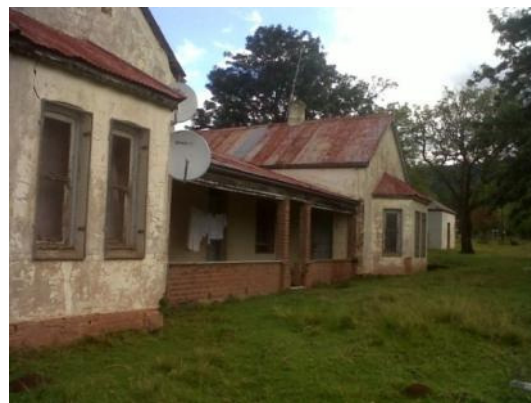
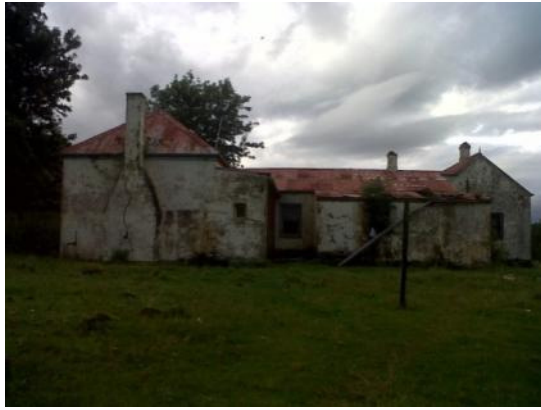
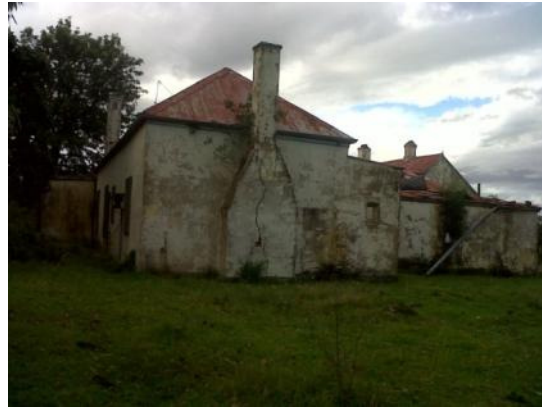
## **D.6 House no 5**

This is a large, sprawling house of similar vintage (ca 1895) with multiple added accretions. It has double projecting bays on the north elevation, and these are joined by a long veranda. It is of mixed construction, mud brick and locally-made fired brick, under a largely hipped corrugated- iron roof. The north elevation still has evidence of fretwork.

As in number 3 above, extensive canalisation leads into the garden which is of interest. Also to note is what was possibly a horse trough located at the north western corner of the house.

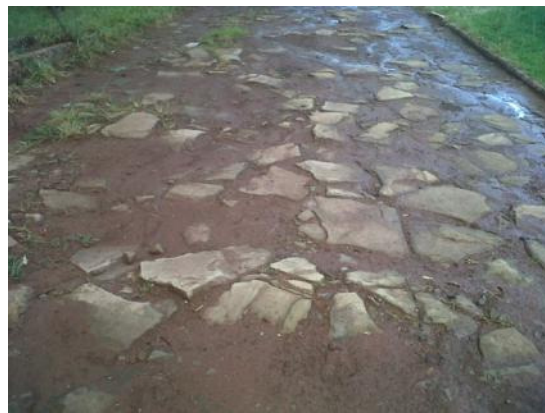
***Fig 88: Flagstones on access road***

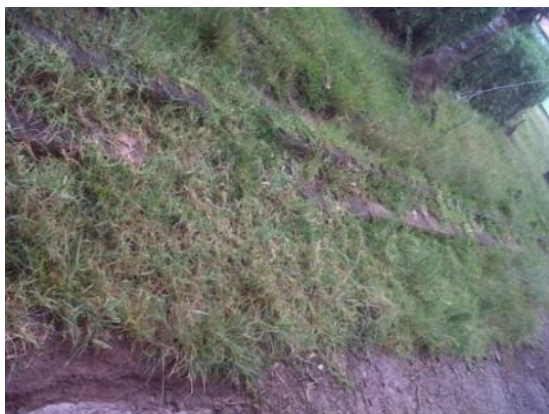
***Fig 89: Water furrow along access road***

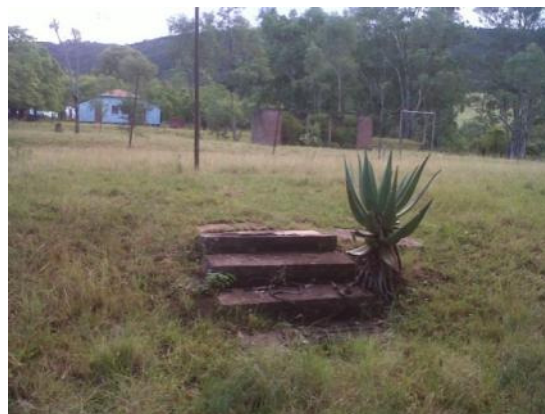
***Fig 90: Stairs to tennis court***
